Manhole Inspection Summary

Manhole # S47K__012MH

Insp Date: **7/28/08 2:15 PM**

Location Address: **2228 cambridge st**

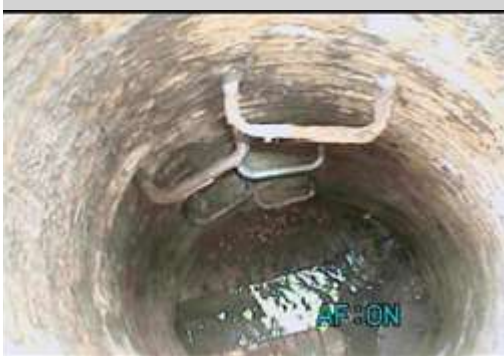
Defect 1

Count: **5** Missing: **0** ☒ **Corroded**

steps

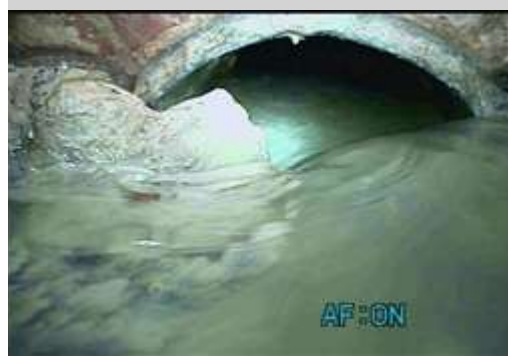
Defect 4

Condition: ☐ Sound ☐ Cracked ☐ Root Intrusion ☐ Deteriorated ☐ Leaks ☒ **Debris**

channel debris

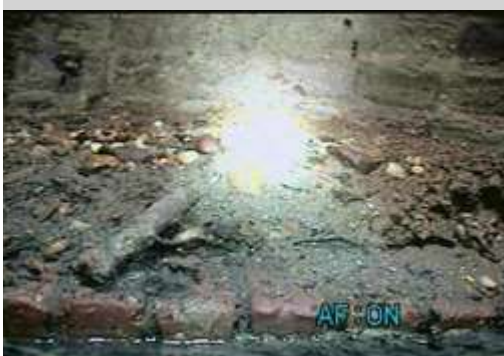
Defect 3

Condition: ☐ Sound ☐ Cracked ☐ Root Intrusion ☐ Deteriorated ☐ Leaks ☒ **Debris**

bench debris

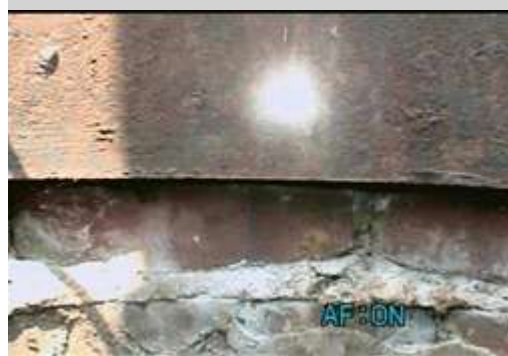
Defect 2

Condition: ☐ Sound ☒ **Cracked** ☐ Root Intrusion ☐ Loose Brick ☒ **Deteriorated**

Chimney cracked, deteriorated

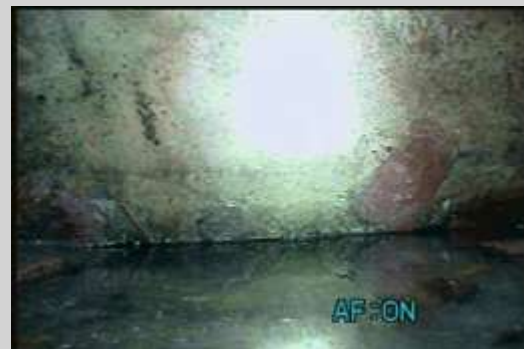
Drop In @ 3 O'Clock

complety under water
